Bluff Response in Glacial Till: South Shore of Lake Erie

Shahalam M.N. Amin

Department of Geography and Geosciences, Bloomsburg University of Pennsylvania, Bloomsburg, PA 17815.

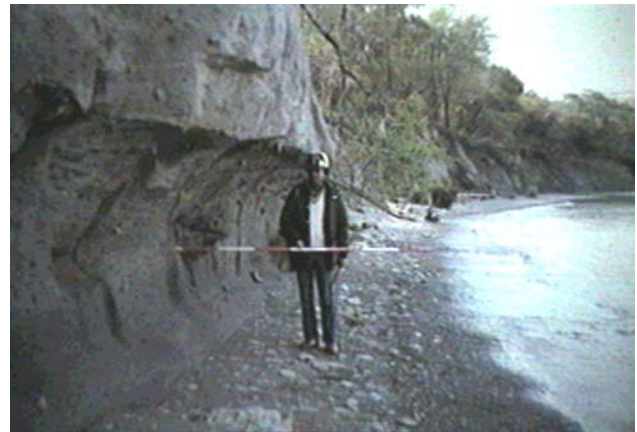
Figure 5: Formation of a concave erosion zone due to wave erosion, and the resulting overhang at Site 1.

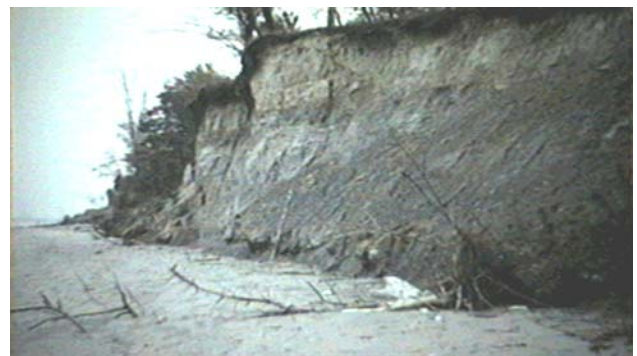
Figure 6: Failure of the overhangs and subsequent removal of talus material by wave activity maintained a near vertical profile at Site 1.

not enough to stop toe erosion. As a result, the bluff was almost vertical, with no sign of stability (Figure 6). Talus cones were observed at the bluff base during five visits from 1987 to 1996, and these provided only temporary protection from wave action. In 1997, pronounced bluff toe and beach erosion were observed once again at Site 1 after an episode of high lake-levels (ranging from 174.5 to 174.9 metres, IGLD-1985) and a very narrow beach (less than two metres). This initiated formation of a concave erosion zone at the bluff base similar to what was observed in the 1986 bluff geometry.

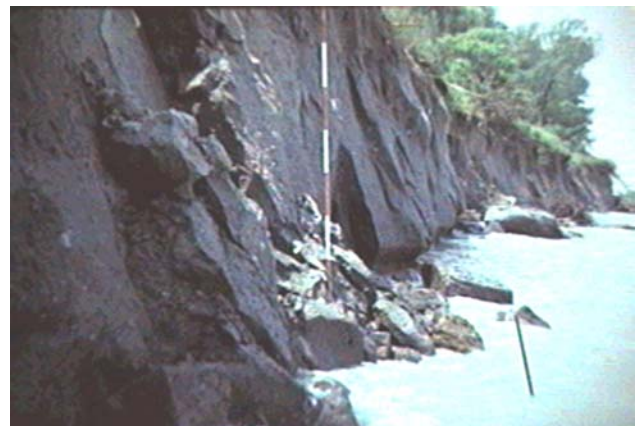
Figure 7: Notch development and subsequent plane failure at Site 2.

In 1986, the low bluff at Site 2 went through a multiple cycle of toe erosion and bluff failure. The relatively narrow beach (less than two metres from April to October) at this site allowed swash and waves to reach the toe more frequently than at other sites, thereby promoting rapid development of notches. Notch development was followed by earth falls that frequently affected the entire bluff up to the crest line (Figure 7). With this process the beach widened significantly (from two to six metres) by the end of the field season in 1986. The beach remained consistently wider (ranging from six to 10 metres, Figure 4) and thicker (thickness was not measured, but observed) and there was little evidence of toe erosion from 1987 to 1996. As expected, reduced or insignificant erosion at the toe of the bluff helped the bluff profile gradually evolve into a more stable slope and finally attain the desired angle of repose (Figure 8). Gradual colonization of the slope with grasses and woody shrubs further reduced sub-aerial erosion, and provided a quasi-equilibrium state of slope stability. This equilibrium was interrupted by further severe beach and toe erosion in the 1997-98 season with marked high lake-levels. Severe toe erosion removed all previously slumped material that had helped attain the angle of repose; the resulting erosion made the profile again almost vertical. The beach narrowed to the width observed in 1986 (about two metres) with wave action eroding the *in situ* toe material. The 1997-98 toe erosion process looked identical to the 1986 process (Amin and Davidson-Arnott, 1995).

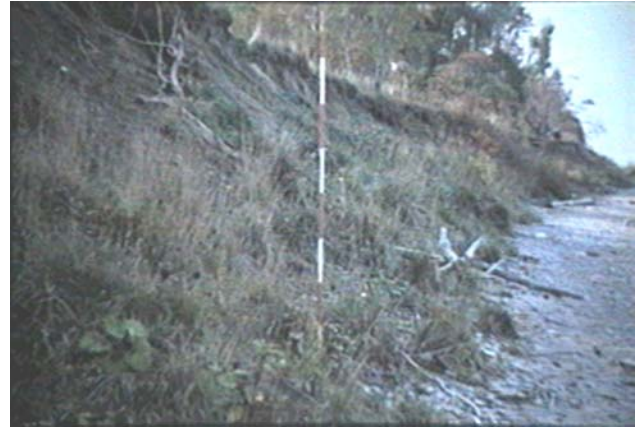
Figure 8: Stable slope at Site 2 due to colonization with grasses and shrubs, thereby reducing sub-aerial erosion.

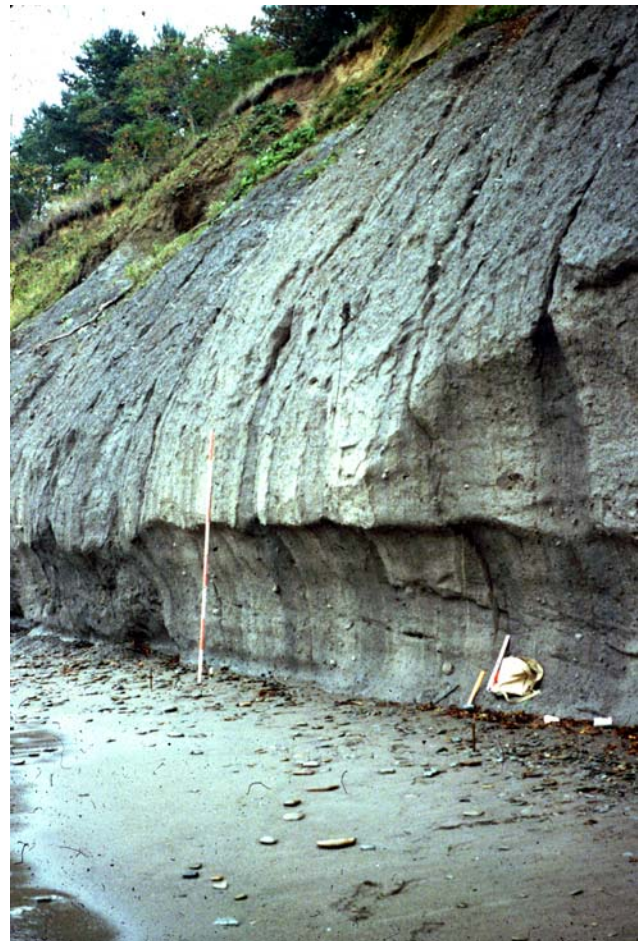
Figure 9: Toe erosion at Site 3 in 1986 resulted in the formation of an arch shaped erosion zone at the base and an associated bulging of the bluff face above the toe area.

The bluff at Site 3 is relatively high (17 metres) and was a sigmoidal shape in 1986 (Figure 9). The resulting erosion form at the toe is described as an arch shaped zone, about 2.00 metres high and 0.75 metres deep at the base. This caused a pronounced bulging of the lower till. The response of the lower part of the bluff to toe erosion was the failure of the bulge in the form of
